Flood Management Evaluation Memorandum

DATE: April 12, 2023

SUBJECT: **FME ID: 101000189**

Project Name: Wastewater Treatment Plant Floodproofing

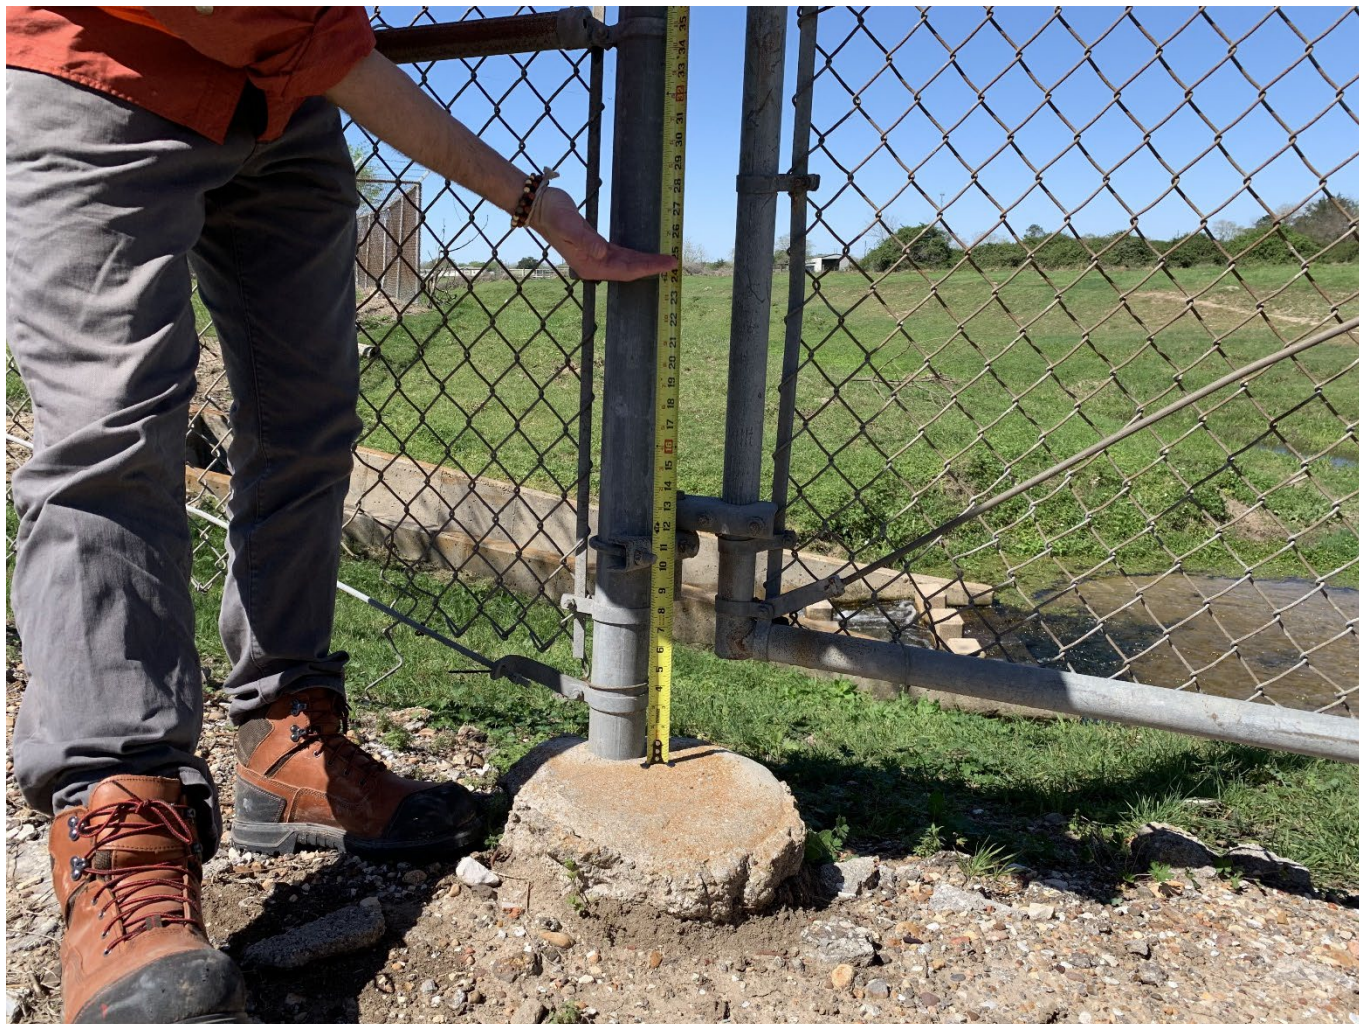
Figure 3: Reported HWM along fence near WWTP outlet

- The plant operator confirmed that the WWTP UV system flooded in the May 2020 event and that this process failure caused the WWTP to not meet effluent standards.
- Of the several estimated HWMs at various locations throughout the plant, the City of Edna had most confidence in a HWM along the fence adjacent to the WWTP outlet. The estimated HWM is two feet above the approximate ground surface elevation of 60.5 ft-msl at this location. This corresponds to an estimated water surface of 62.5 ft-msl in the May 2020 event. See Figure 3.

- This elevation and location are based on recollection from an event over 2 years ago and may not be accurate.
- The approximate critical elevation of the UV system that would impact operations is between 62.3 and 62.7 ft-msl.

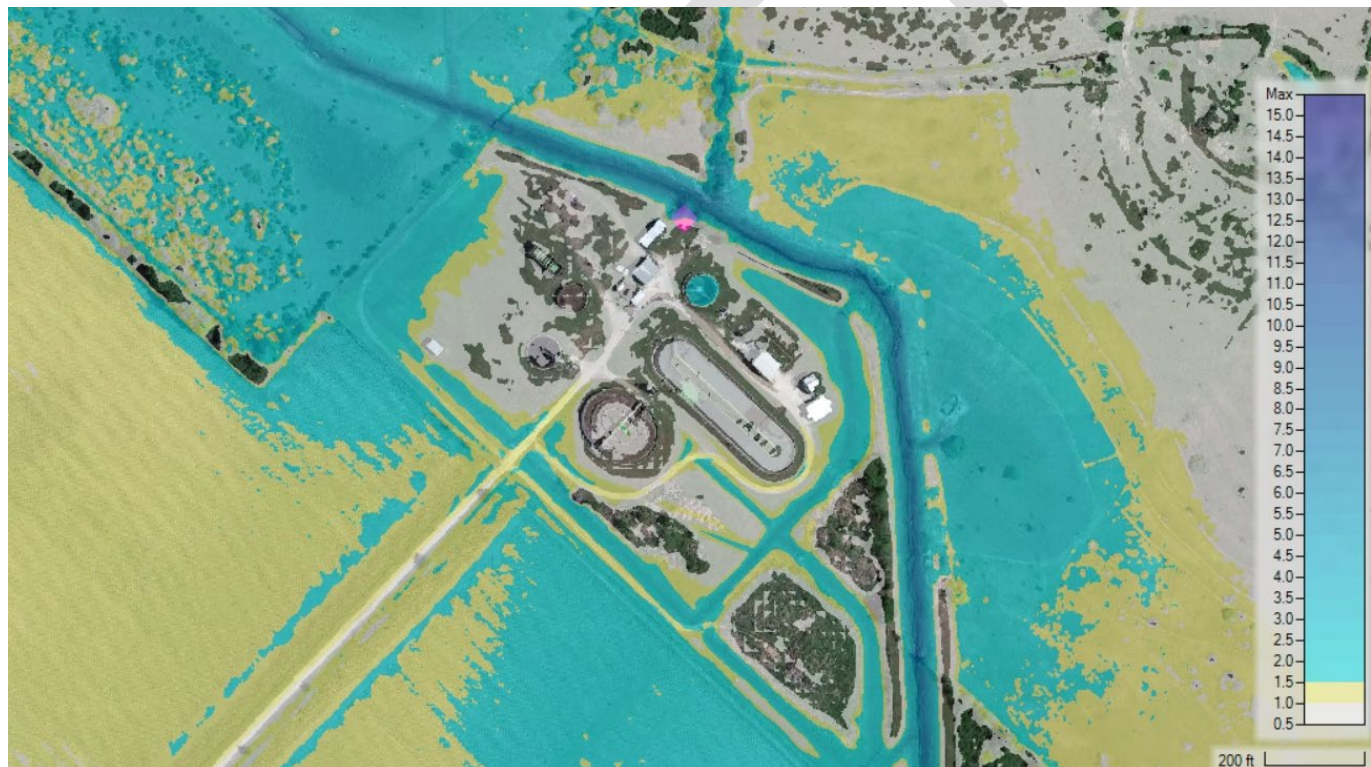
- Hydraulic model roughness was adjusted attempting to align hydrologic output, the high-water mark, and hydraulic output.
 - A roughness of 0.1 was applied to the entire 2D domain. This value of 0.1 is assumed to be the maximum roughness that could be considered reasonable for the areas.
 - After maximizing the roughness at the site, modeled depths in the record event at the high-water mark location were approximately 61.5 ft-msl, which is one foot lower than the approximate HWM and one foot lower than the UV system.
 - The peak flow required to reproduce depths that would flood the UV system exceed the 100-year storm.
- An analysis using ROM to evaluate localized site drainage were performed and produced depths adjacent to the UV system of approximately 1". These depths are assumed to not cause flood damage.

The result of the roughness changes in Table 6 below demonstrate that model adjustment was not sufficient to align with the measured HWM of 62.5 ft-msl nor conclude that the WWTP was inundated from local or riverine flooding.

Figure 6: May 2020 Historical Event Combined Creek and Local Flood Depth (includes ROM)

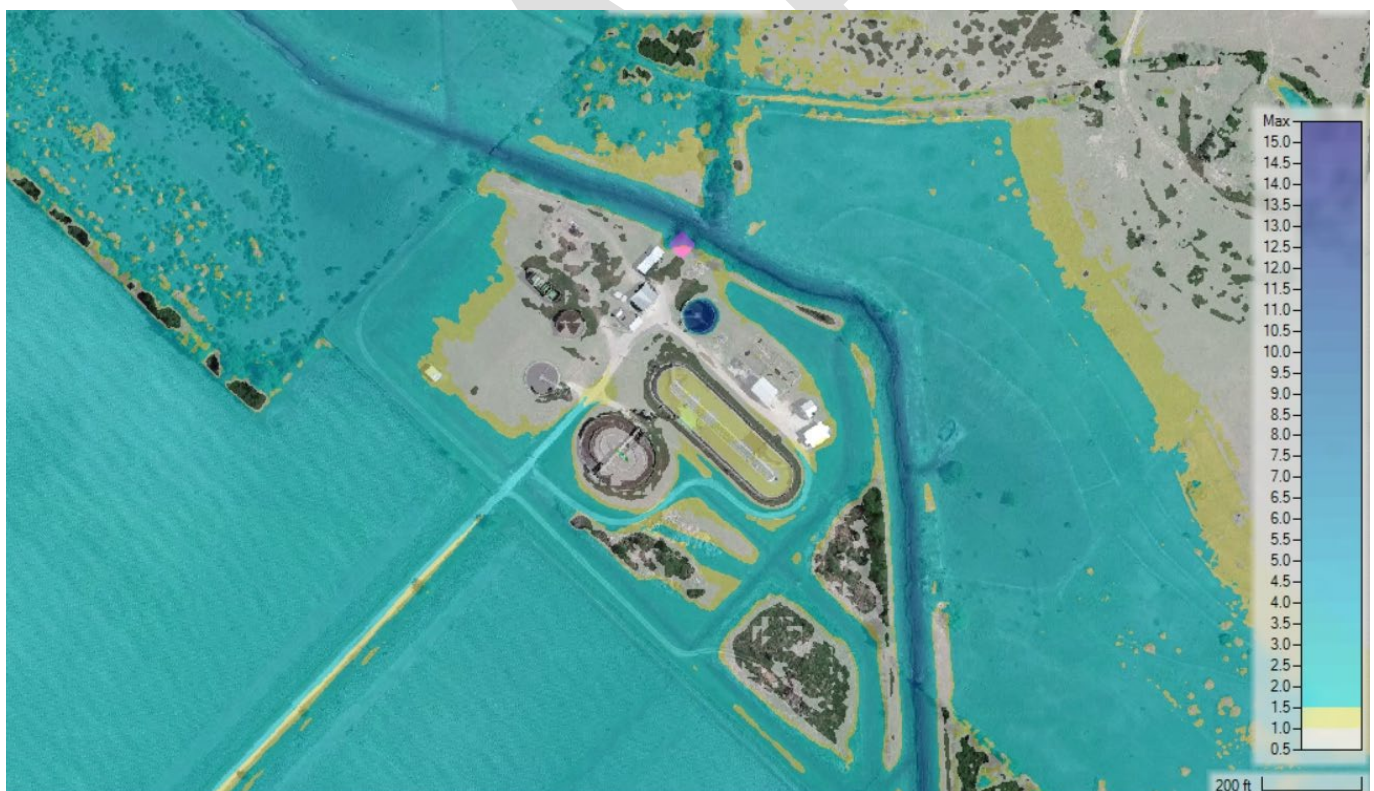
Some limited flood risk exists at the site, however, most of the infrastructure including the UV system appear to be at an elevation above the estimated 100-year design storm. There does not appear to be significant increased flood risk after including localized rainfall and drainage effects in the model simulation. Moreover, the analysis results from the 2020 storm event re-creation do not support the assumption that flood waters from the East Ditch or onsite areas caused the WWTP shutdown during the 2020 storm event.

Figure 7: Existing Condition 100-year Combined Creek and Local Flood Depth
