Flood Management Evaluation Memorandum

PROJECT: LCRA Contract No. 5809
Halff AVO 43796.001
HDR PN 10304676

SUBJECT: **FME ID: 101000189**
Project Sponsor: City of Edna (Municipality)
Project Name: Wastewater Treatment Plant Floodproofing

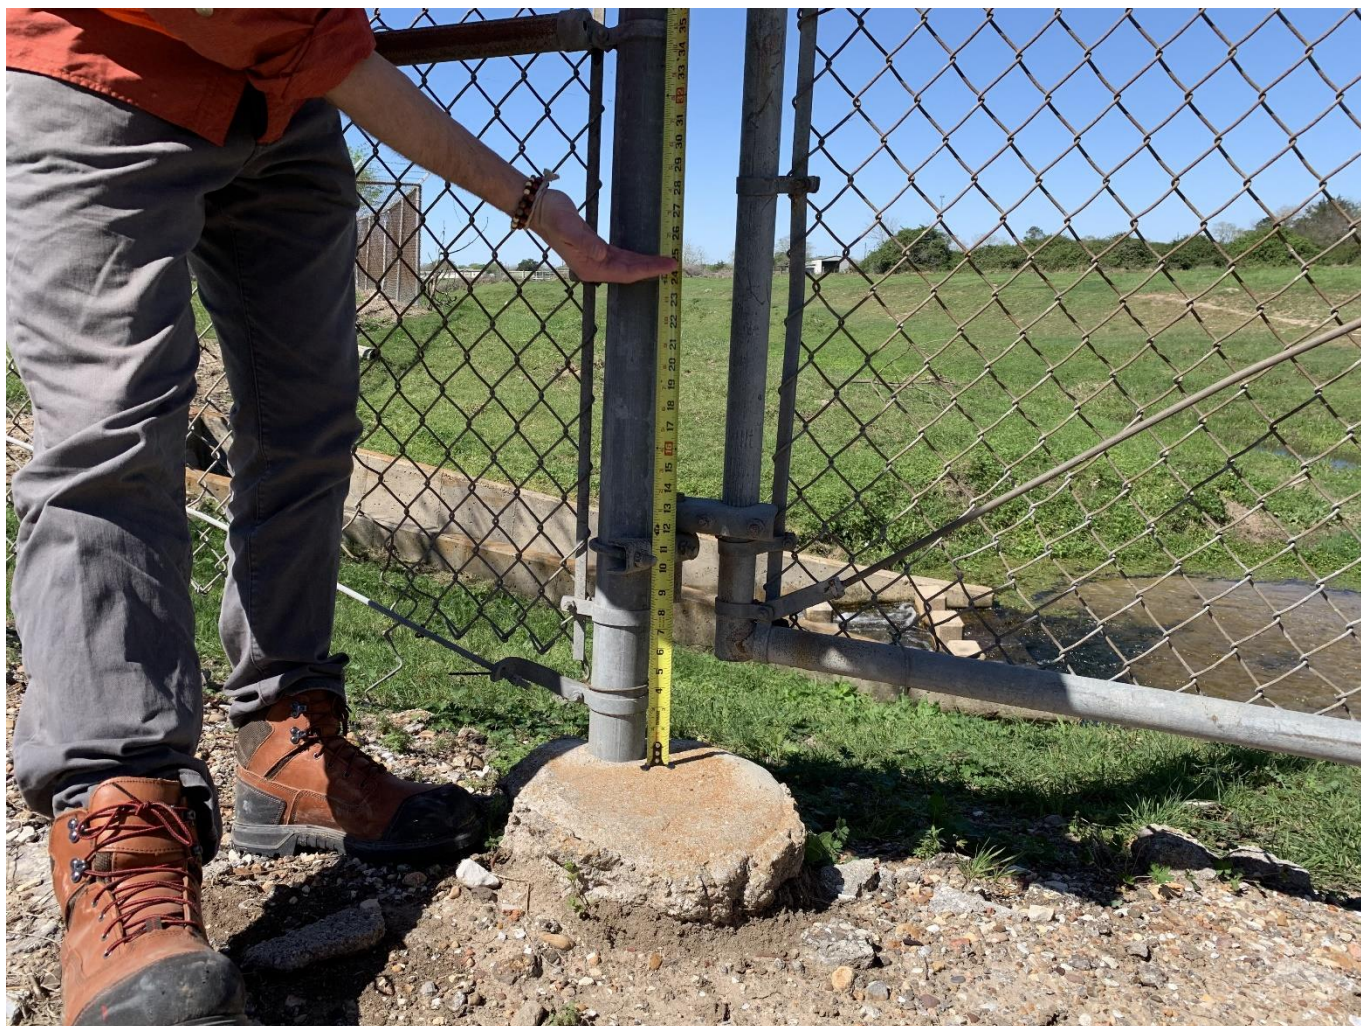
Figure 3: Reported HWM along fence near WWTP outlet

- The plant operator confirmed that the WWTP UV system flooded in the May 2020 event and that this process failure caused the WWTP to not meet effluent standards.
- Of the several estimated HWMs at various locations throughout the plant, the City of Edna had most confidence in a HWM along the fence adjacent to the WWTP outlet. The estimated HWM is two feet above the approximate ground surface elevation of 60.5 ft-msl at this location. This corresponds to an estimated water surface of 62.5 ft-msl in the May 2020 event. See Figure 3.

- This elevation and location are based on recollection from an event over 2 years ago and may not be accurate.
- The approximate critical elevation of the UV system that would impact operations is between 62.3 and 62.7 ft-msl.

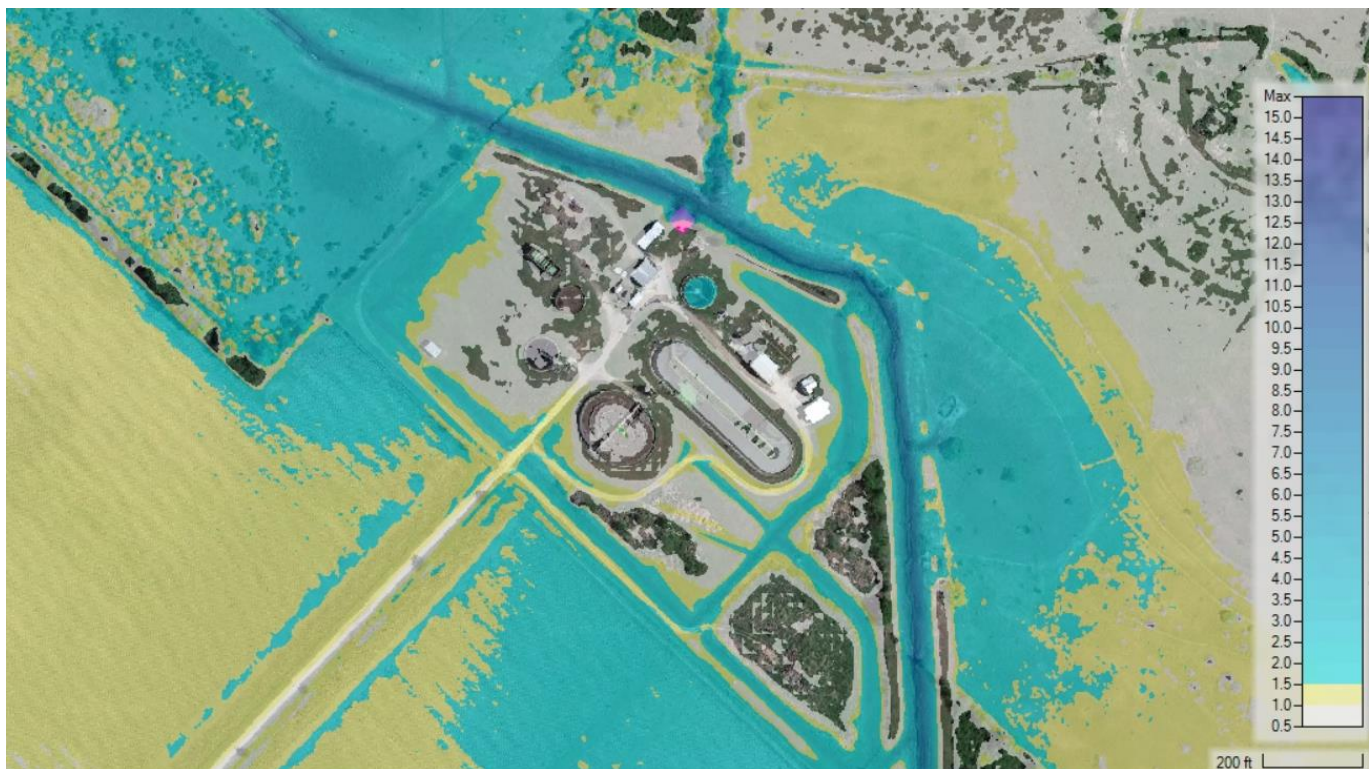
Figure 6: May 2020 Historical Event Combined Creek and Local Flood Depth (includes ROM)

Considering the potential unreliability of HWM data from an event from over 2 years ago and the initial model results, HDR estimates that it was unlikely that creek or local flooding directly caused the UV system failure in May 2020. The UV system and a large portion of the WWTP infrastructure is on relatively higher terrain than adjacent surrounding areas. The cause of the failure at the UV process is uncertain and further investigation is suggested.

The result of the roughness changes in Table 6 below demonstrate that model adjustment was not sufficient to align with the measured HWM of 62.5 ft-msl nor conclude that the WWTP was inundated from local or riverine flooding.

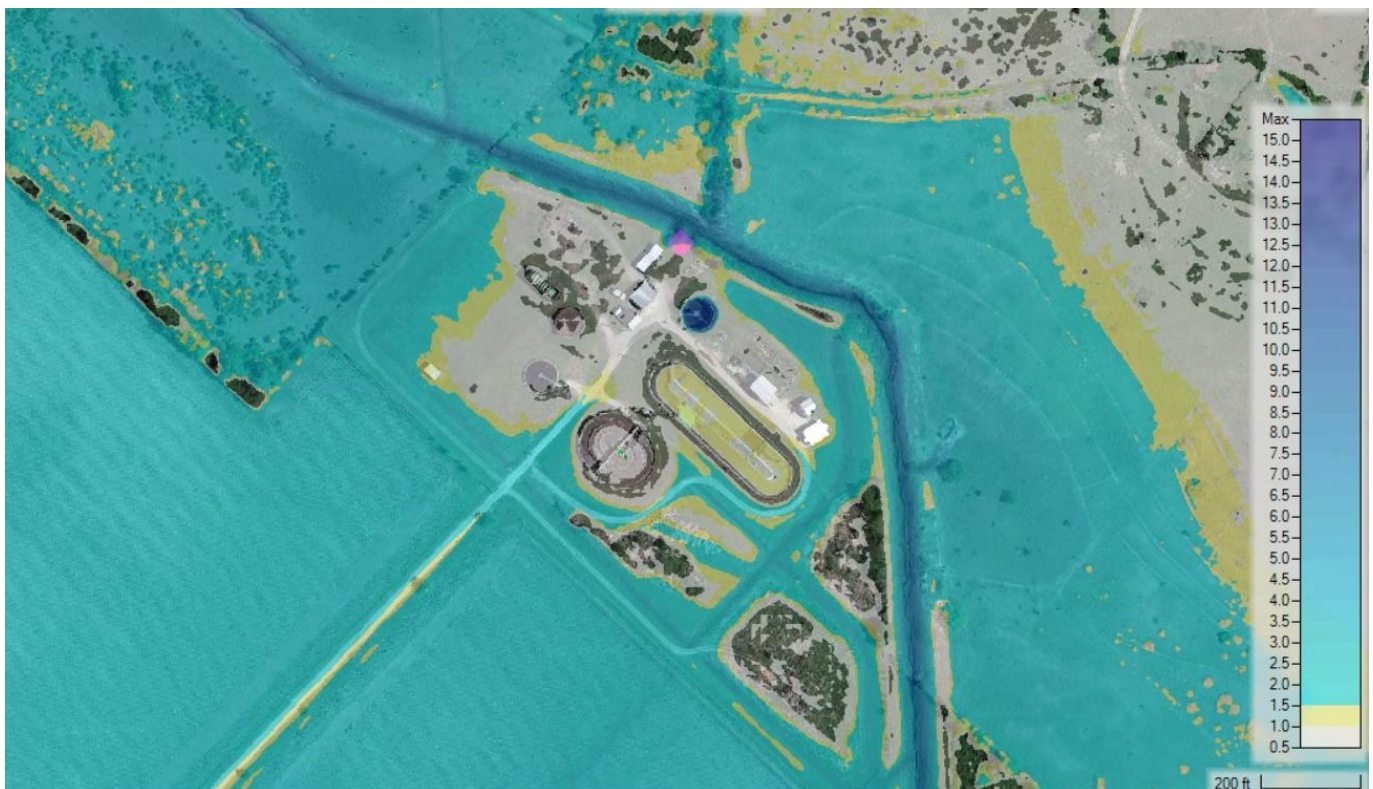
Figure 7: Existing Condition 100-year Combined Creek and Local Flood Depth

Some limited flood risk exists at the site, however, most of the infrastructure including the UV system appear to be at an elevation above the estimated 100-year design storm. There does not appear to be significant increased flood risk after including localized rainfall and drainage effects in the model simulation. Moreover, the analysis results from the 2020 storm event re-creation do not support the assumption that flood waters from the East Ditch or onsite areas caused the WWTP shutdown during the 2020 storm event.

Based on a preliminary assessment of the WWTP operations, there may be plant hydraulic processes that may be adversely impacted by excessive inflow and infiltration (I&I) that could cause a failure of the UV system.

Based on the findings presented in this Technical Memorandum it is recommended that Flood Management Evaluation No. (101000189) be removed from the Regional Flood Plan. The City of Edna concurs with this
